Analysis of Concrete Cracks and damage on Base Slab of Caissons at the Manufacturing Stage taking into account the Settlements of the Backfill and the IP-CCVs

The objective of this article is to analyze the causes and the state of the damaged parts of the caissons during their embarkation on the floating dock, as part of the realization of the new container terminal project at the Djen Djen Port, in Jijel province in Algeria, and to take the necessary measures for the repair and prevention of any recurrence. On the workshop site, following the displacement from the sliding formwork station to the curing station, the appearance of cracks in the base slab of the fifth caisson was observed, with the same characteristics as the cracks that occurred on the base of the previous caissons. We have studied this phenomenon and make analysis with the observations, the explanation and the measures to be taken in order to prevent the repetition of this problem, because the topographic verification of the leveling of the workshop platform stations and the backfill settlement verification of the same platform are carried out with good results; in contrast with the differential settlement of the

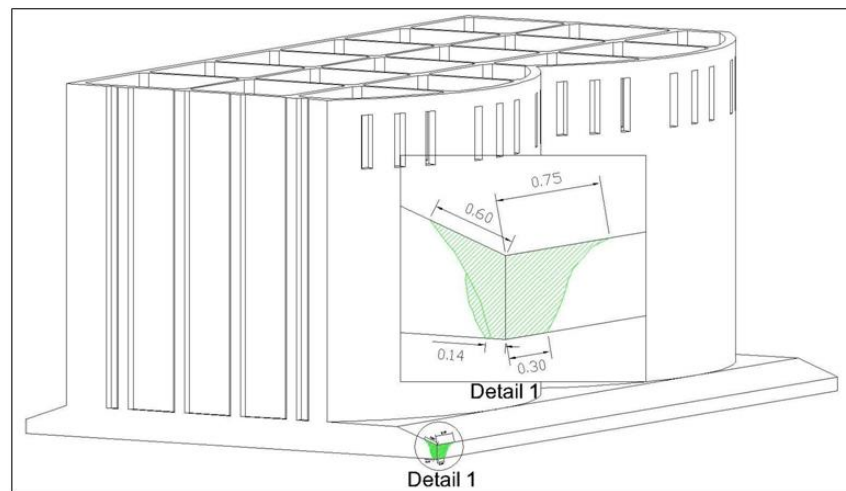
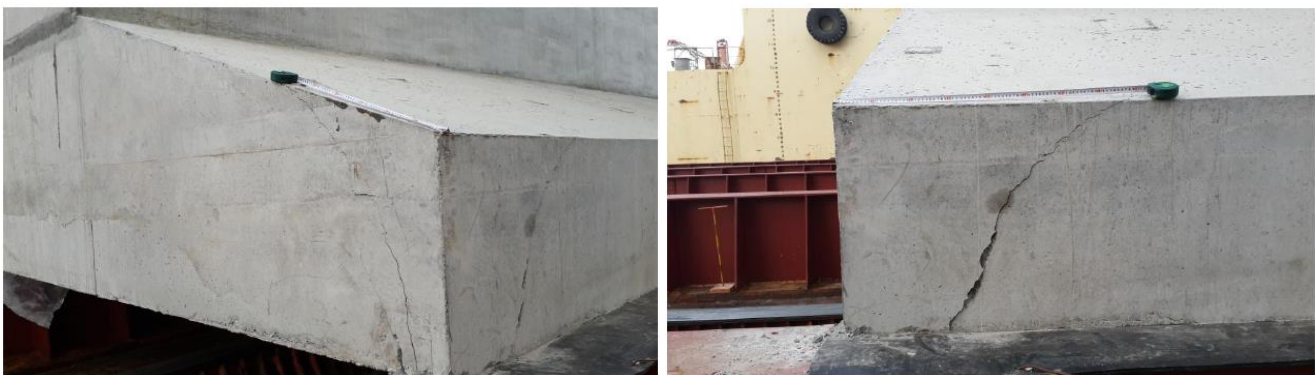
There was damage to the caisson when boarding the floating dock as in figure (4). The size is approximately 80cm X 60cm. Since this damage only occurred in part of the corner of the caisson's slab (figure 4 a), it can be repaired by stitching and concreting (Micro-concrete). The objective is to analyze the causes and the state of the damaged parts of the caissons (Figure 5 to 9) during the loading of the caissons on the floating dock from the step of the base slab, step of slip-form and step of curing, in order to take measurements necessary for the repair and prevention of recurrence.

**Figure 4: (a)** State of the damaged part.

**Figure 4: (b)** Photographs and details of the damage of a caisson when boarding floating dock (size is about 80cm x 60cm) Since this damage occurred only in part of the corner of the caisson, it is repairable by the chipping and concrete (Micro concrete).

The damaged part is quite large and it is difficult to repair it with the crack repair method (figure 4a & 4b). Therefore, as below, we will destroy the damaged part, expose the reinforcement, install the formwork, and then repair with the concrete (for caisson) or the micro-concrete, according to the following methodology;

- ✓ Chipping;
 - Stitching/ chipping of the bottom and lateral part.
- ✓ Formwork;
 - Installation of the formwork for the base slab with wood (or metallic).
 - For the exterior wall, install higher ($h = 100$ to $150\text{m} / \text{m}$ from the damaged area).
- ✓ Injection of the repair product;
 - The repair materials will be the one mentioned in the methodology.
 - During injection, up to the height of the installed formwork.
 - When injecting, compacting and leveling with wooden hammer, etc.
- ✓ Using the repair product;
 - We can use a repair product (EMACO, other products) in case of insufficient micro-concrete.
- ✓ Curing;
 - Curing by water in the surface of the mortar injection zone.
- ✓ Finishing;
 - After stripping, finish the protruding parts of the mortar.

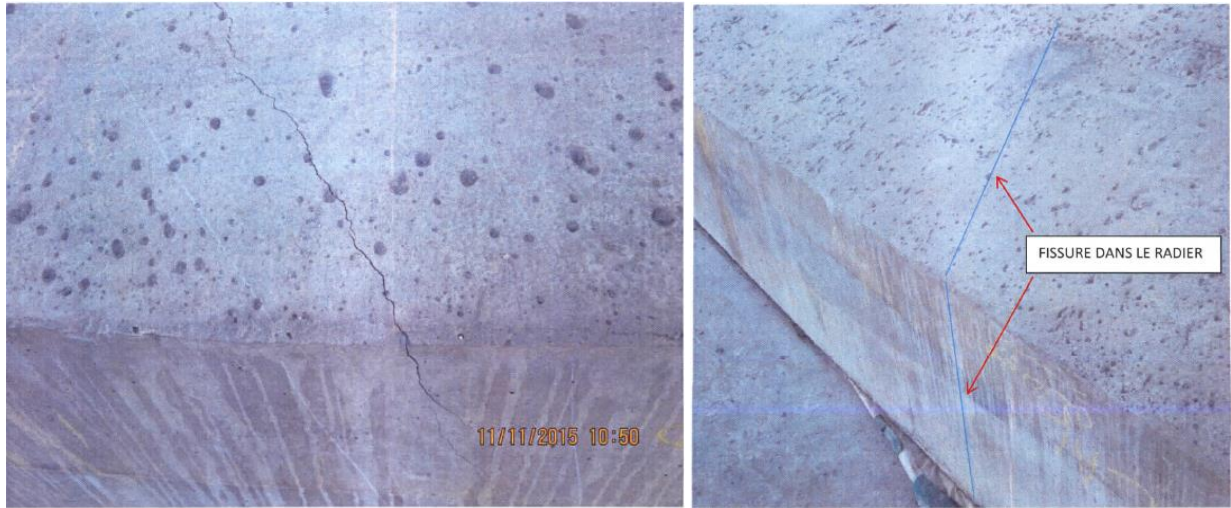
Figure 4: (c) Photographs of the cracks of the caissons' slab.

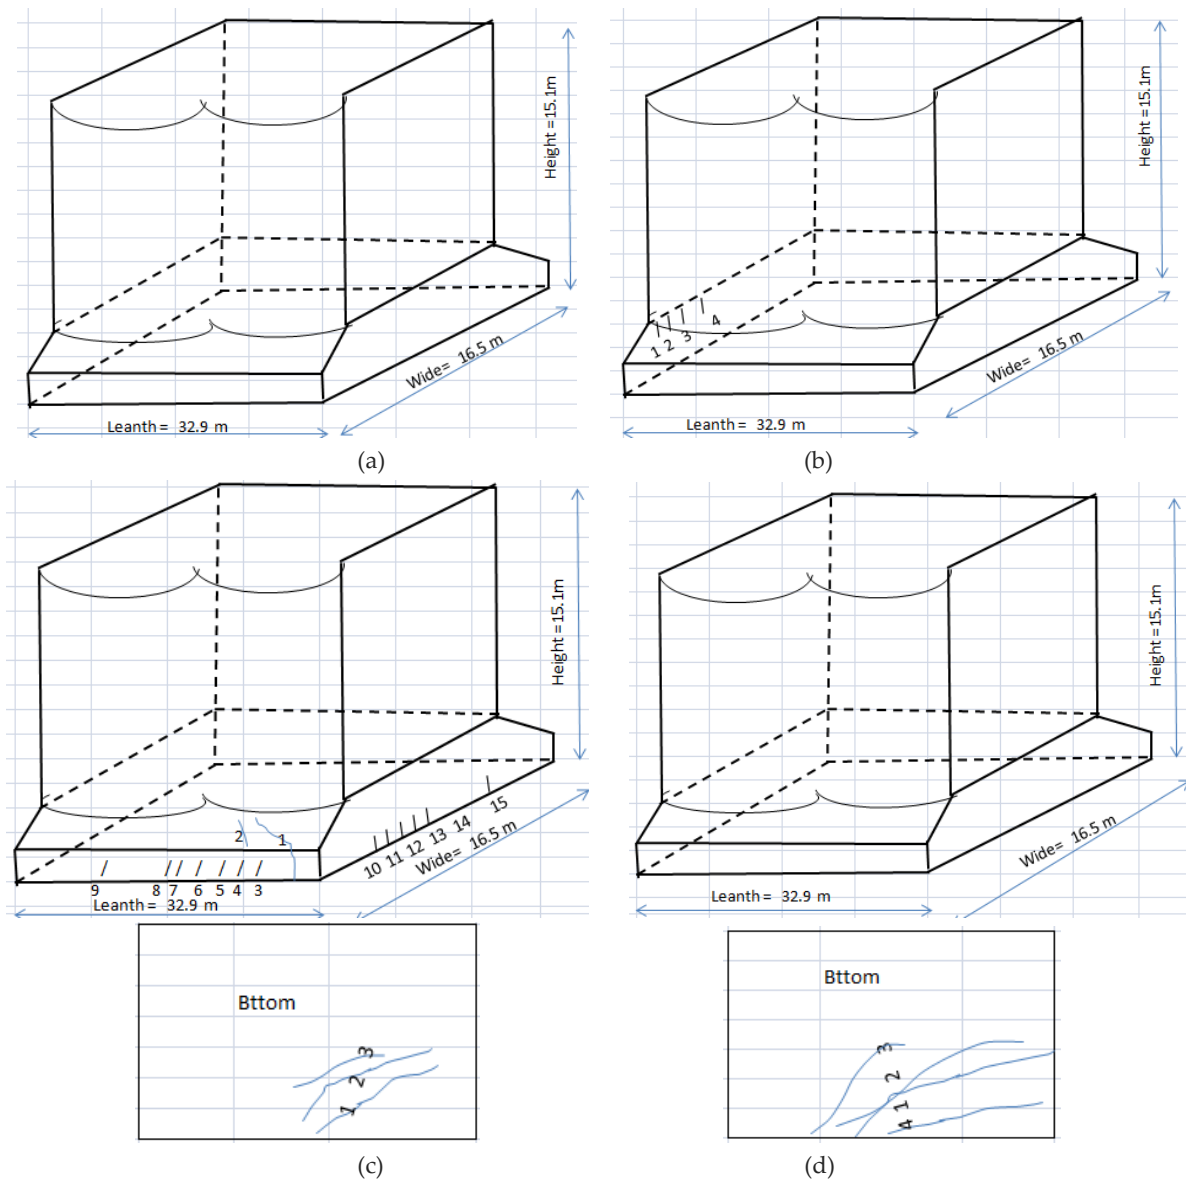
Figure 5: Checking the cracks of the caisson N°1; (a) step 1 (slab), (b) step 2 (wall), (c) step 3 (curing), (d) step 4 (on floating dock).

We can notice the appearance of four to fifth cracks on the left side parts of the caissons' slab after the start of manufacture of its walls with the exception of the second caisson (N°2) which showed two cracks on the foot of the caisson, and for the third (N°3) and fourth (N°4) caissons, which appear a superficial shrinkage of its concrete on the foot of the caisson, but most of the cracks appear after moving the caissons from fabrication of caisson walls area (step 2) to the curing area (step 3), where these cracks reach down to the bottom of the caissons' slab. It has also been shown that an increase in the length of some of the existing cracks, some of which may reach the top face of the caissons slab (figure 8), without any new cracks occurring during transfer from the curing area (Step 3) to the floating dock (Step 4).

We can notice that all the cracks are apparent with the beginning of the manufacture of the walls of the caissons (Step 2); this indicates that the cracks are not due to poor concrete quality or a concrete formulation (Design) that does not meet the necessary requirements.

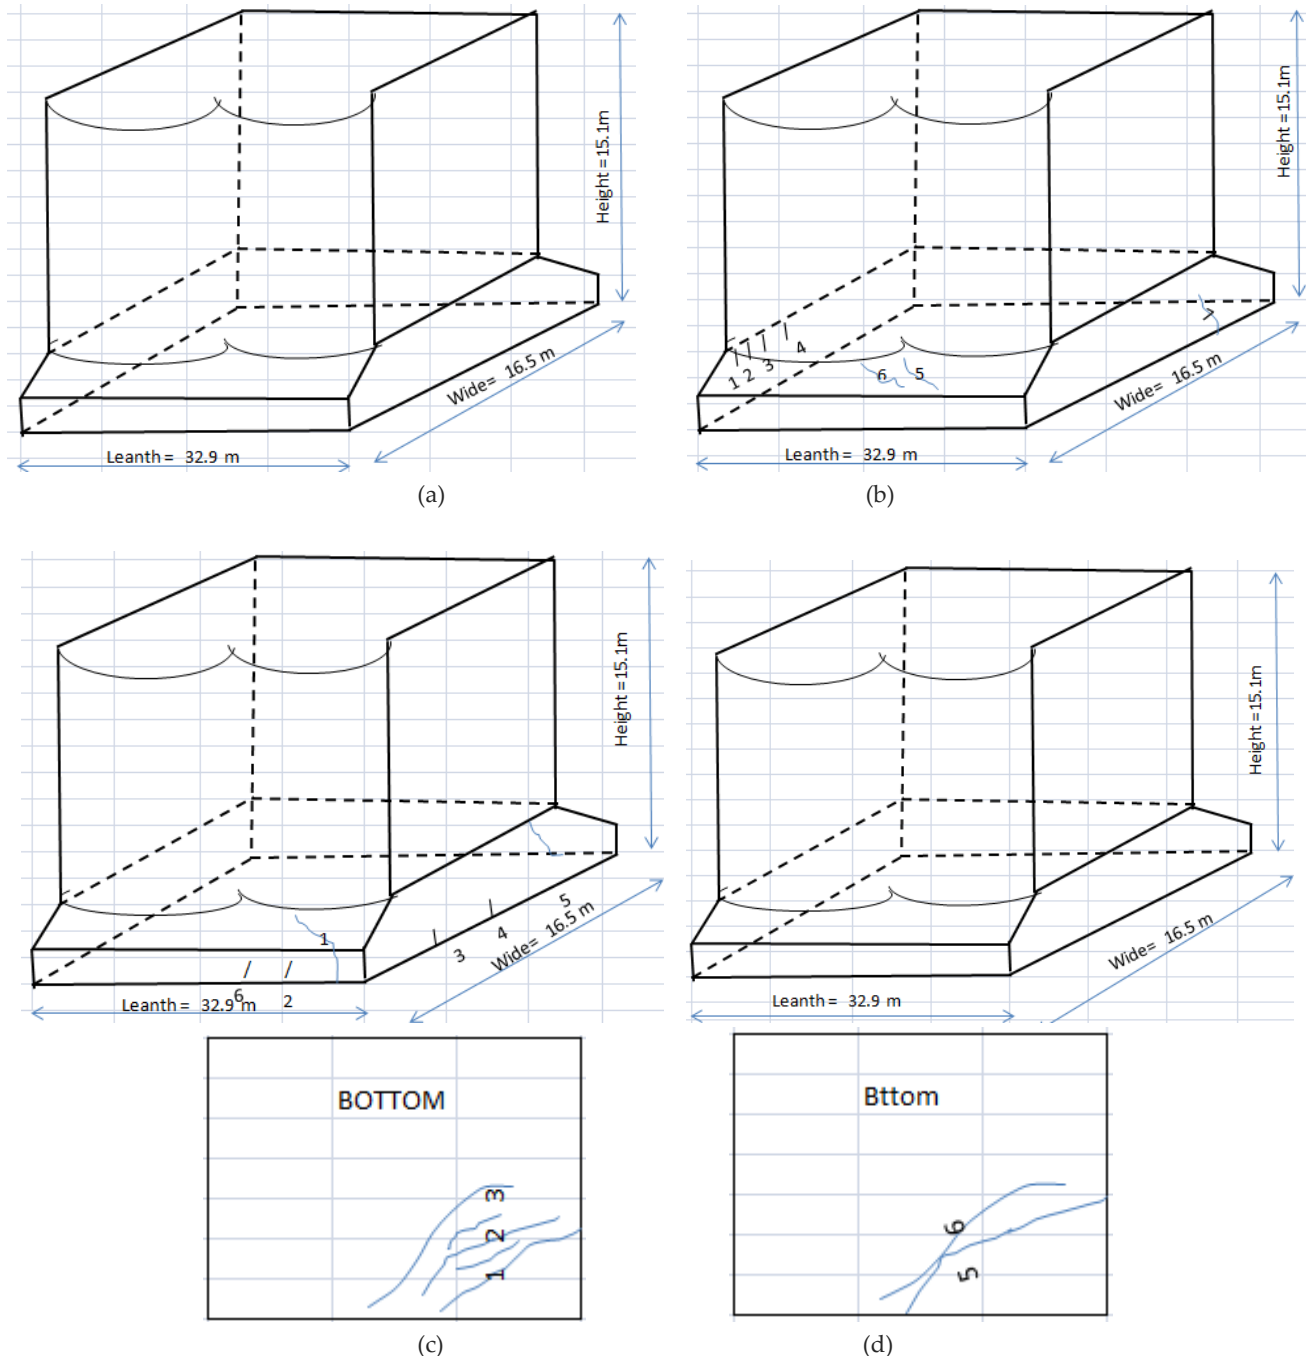
Figure 6: Checking the cracks of the caisson N°2; (a) step 1 (slab), (b) step 2 (wall), (c) step 3 (curing), (d) step 4 (on floating dock).

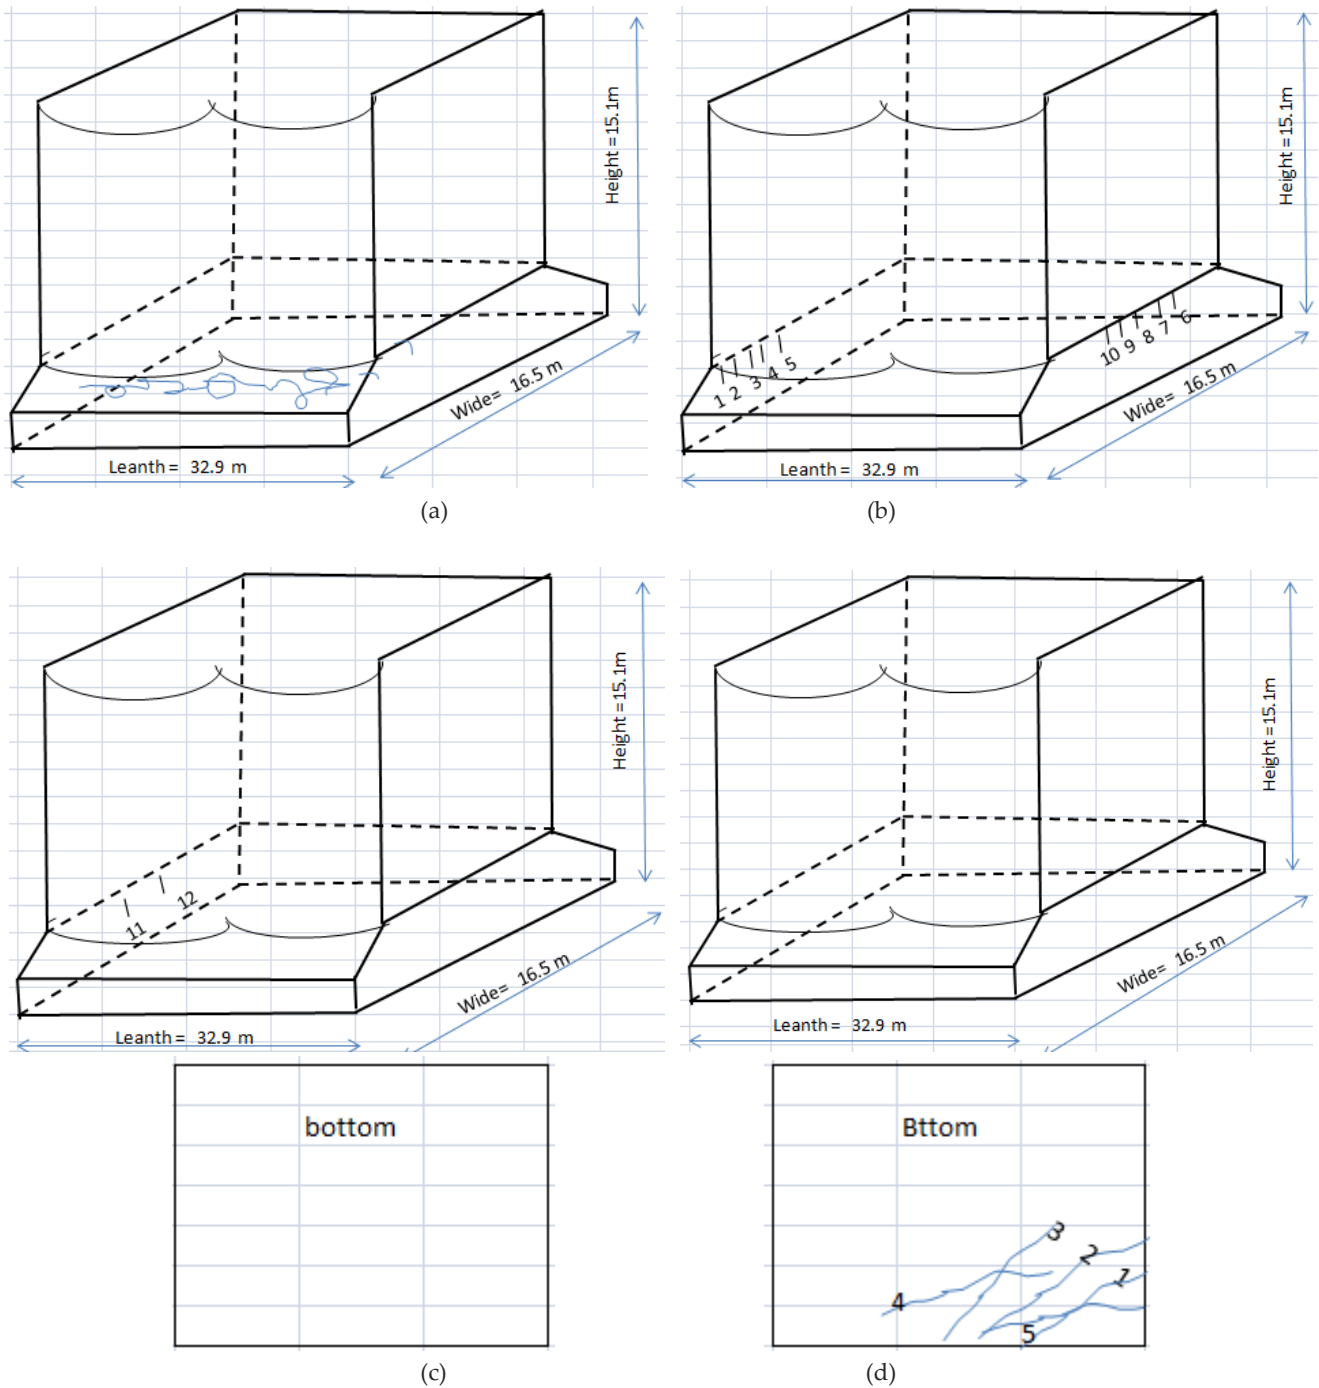
Figure 7: Checking the cracks of the caisson N°3; (a) step 1 (slab), (b) step 2 (wall), (c) step 3 (curing), (d) step 4 (on floating dock).

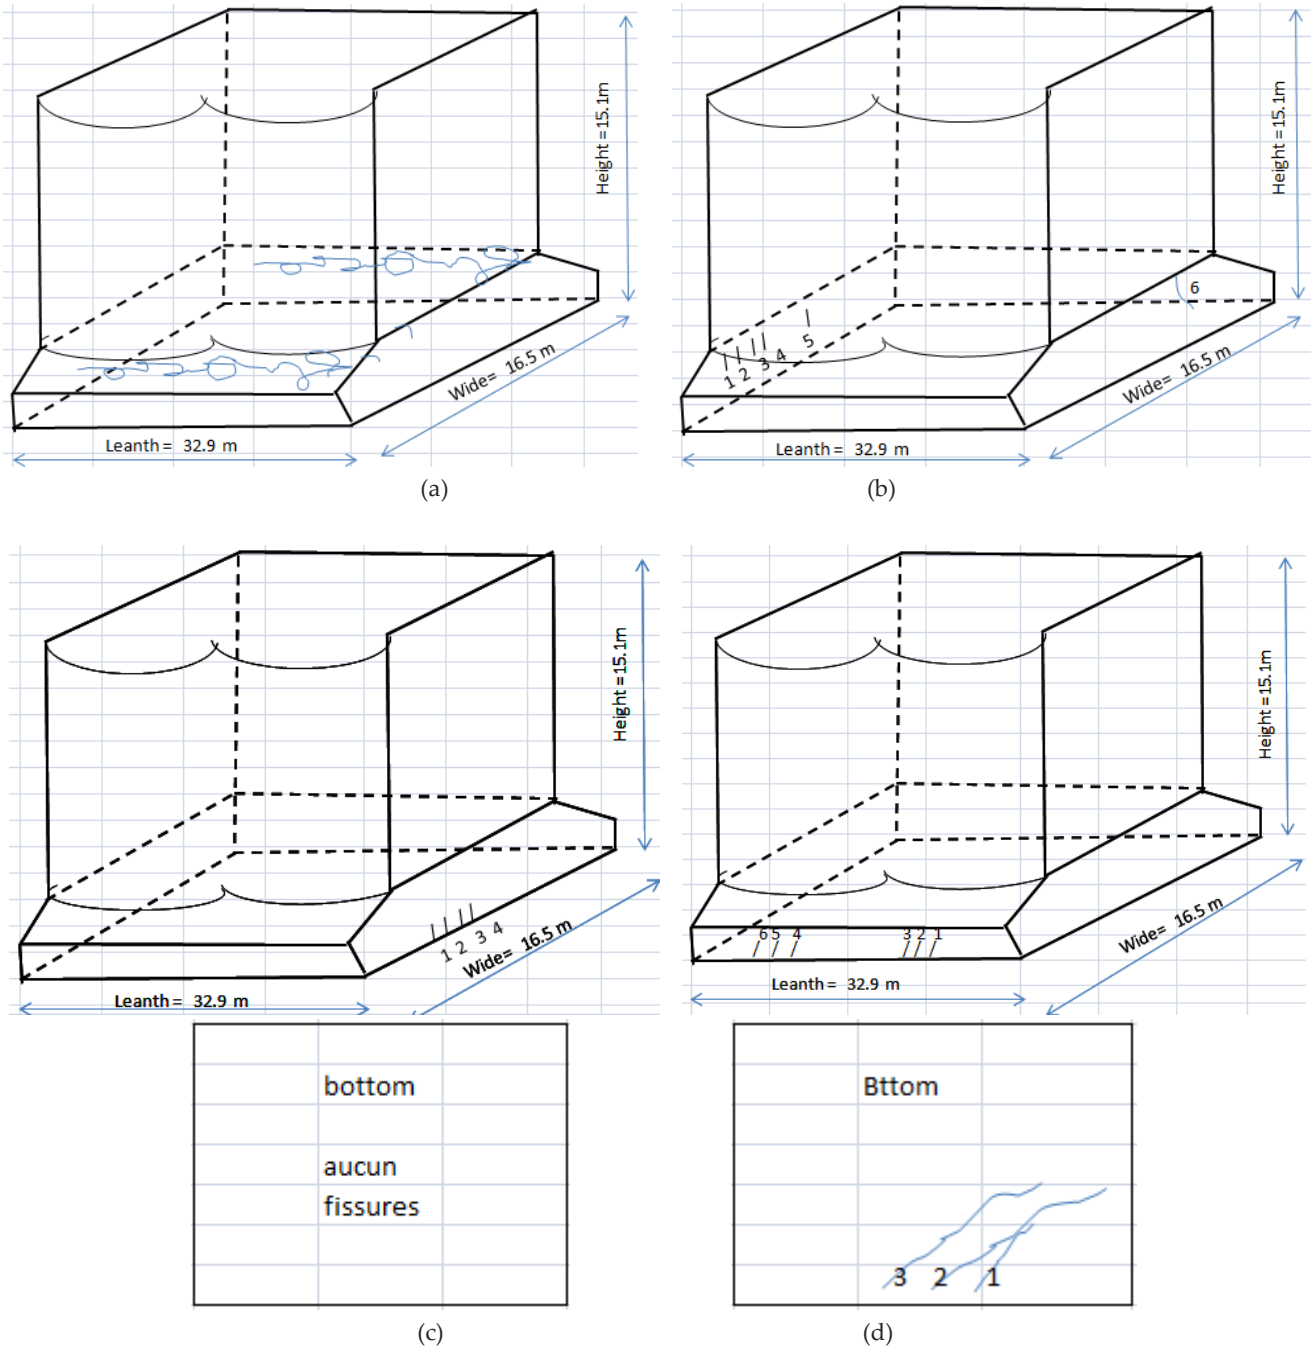
Figure 8: Checking the cracks of the caisson N°4; (a) step 1 (slab), (b) step 2 (wall), (c) step 3 (curing), (d) step 4 (on floating dock).

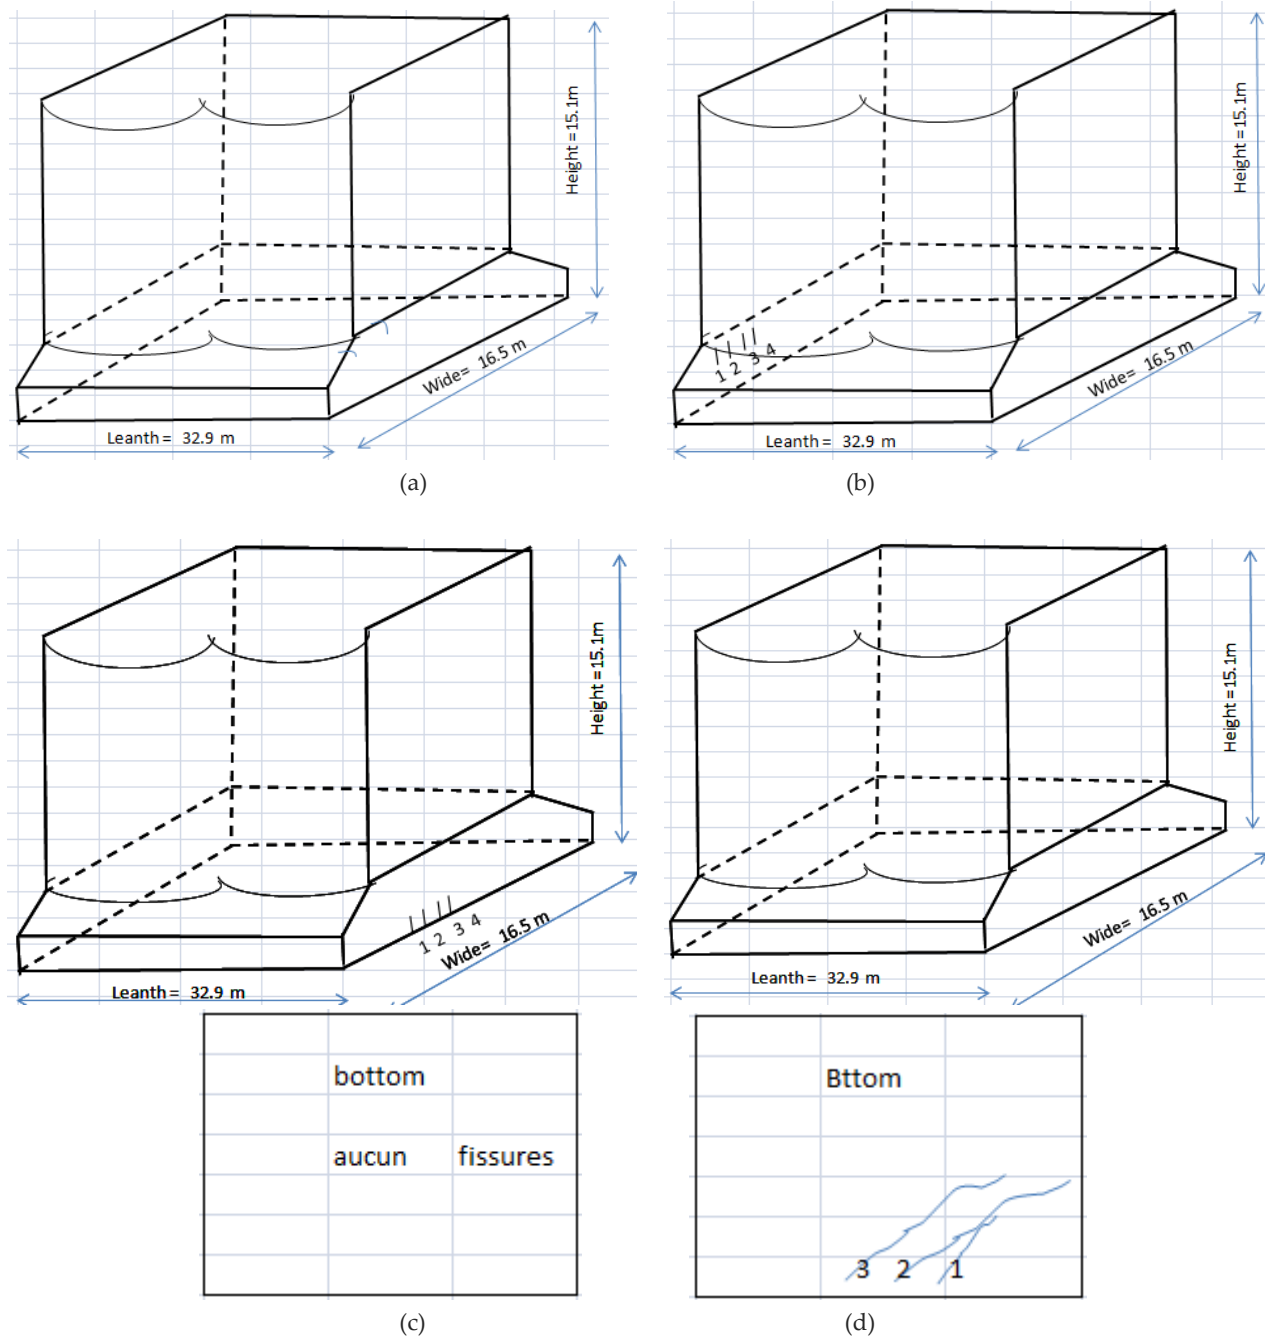
Figure 9: Checking the cracks of the caisson N°5; (a) step 1 (slab), (b) step 2 (wall), (c) step 3 (curing), (d) step 4 (on floating dock).

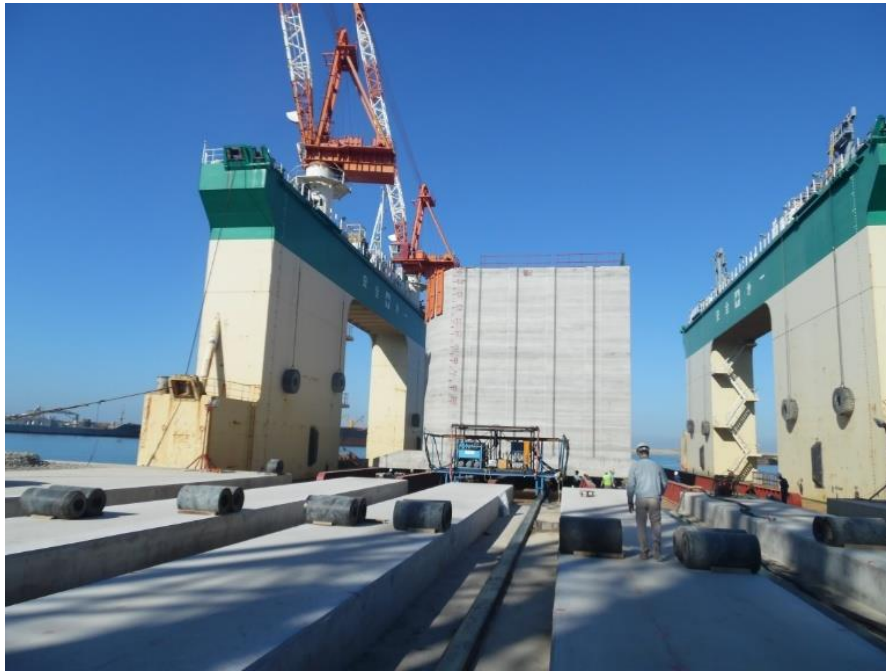
During the operation of the IP-CCV, the contractor will have a staff for each corner (front and back) and will communicate continuously by radio to monitor the operation to the millimeter and ensure the regular lifting and lowering of the caisson. And also, when lifting and lowering the IP-CCV, the contractor will have a supervisor to do to unforeseen cases. In addition, after completion of caisson fabrication, the contractor will invite the supplier supervisor (Bygging-Uddemann) to verify any problems that have occurred. In addition, to prevent the problem, the rubber plate will be partially cut to further minimize the difference in level between the caisson slab and the support (figure 17), and also, because there is a great distance between the extra supports on the floating dock as step 2 (walls) and step 3 (curing).

Figure 17: the rubber plate on the plat-form of the curing station (step 3).
