Evaluations of distresses in pavement layers for selected locations in southeastern Nigeria

Apata AC, Obiora IJ, Imoh UU. Evaluations of distresses in pavement layers for selected locations in southeastern Nigeria. *Indian Journal of Engineering*, 2021, 18(50), 433-445

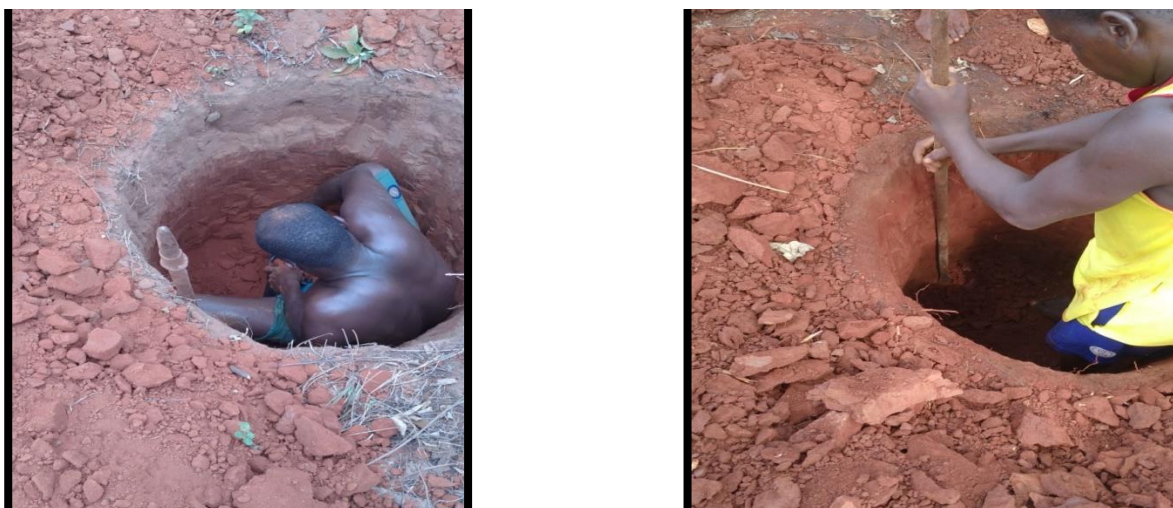
Fig.1: Soil samples collection from test pits

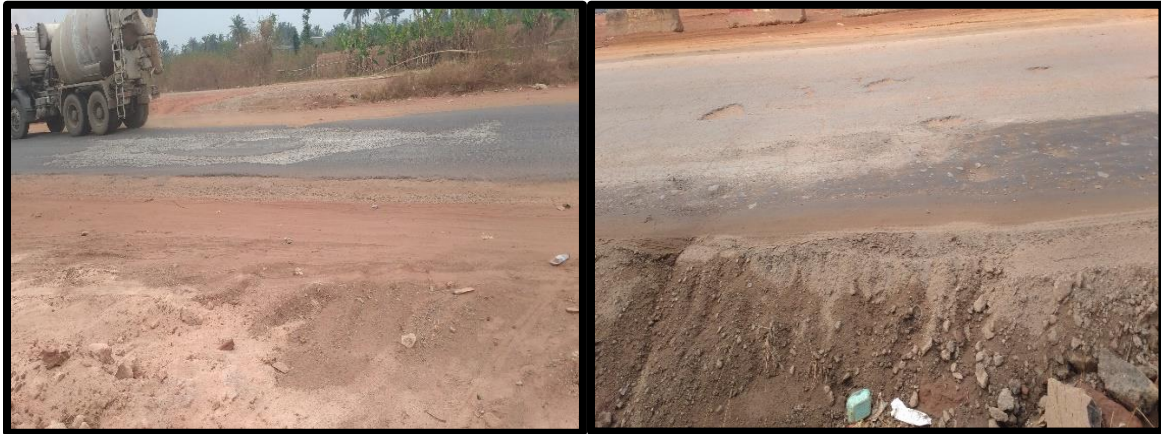
Fig. 2: Distressed portions of the road pavements

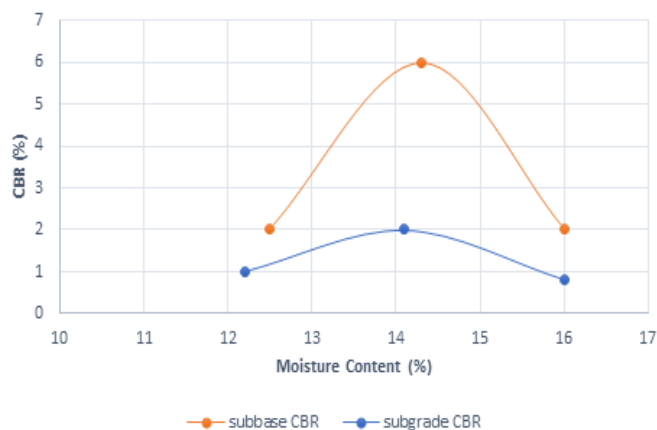
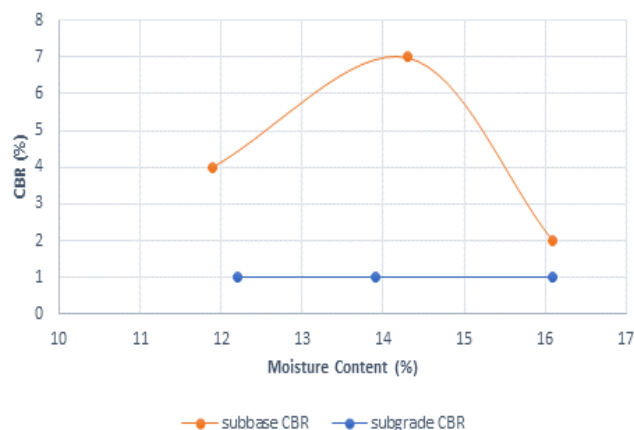
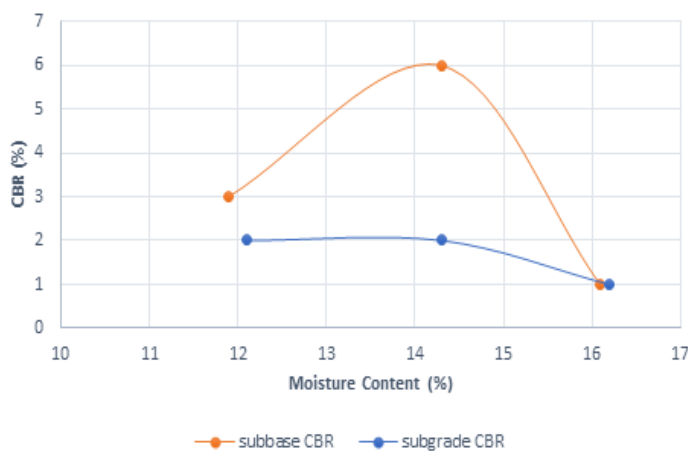
Fig. 3(a): CBR versus Moisture Content for Sample SSA1

Fig. 3(b): CBR versus Moisture Content for Sample SSA2

Fig. 3(c): CBR versus Moisture Content for Sample SSA3

From Figures 3(a) to 3(c), it can be observed that the CBR values at OMC for the sub-base soils range from 6% to 7%, while those for the subgrade soils range between 1% and 2%. The minimum CBR value of a sub-base soil should be 20% and 30% for traffic up to 2 msa and traffic exceeding 2 msa respectively. Also, the minimum CBR value for a subgrade soil is usually 6%, although subgrade characterization recommends 10% [4]. Therefore, the CBR values are not good enough for sub-base and subgrade layers, perhaps as a result of the high percentage of fines as highlighted in the particle size distribution (Table 1).

Three-point CBR values have been plotted against moisture contents in Figures 3 to 5. The three-point CBR provides a clear understanding of the ground conditions under different conditions. The samples are usually prepared in three different moulds of different densities and moisture contents. This allows the soils' CBR performance to be understood at different levels of compaction as opposed to the one-point test that is very specific to a particular density and moisture content.

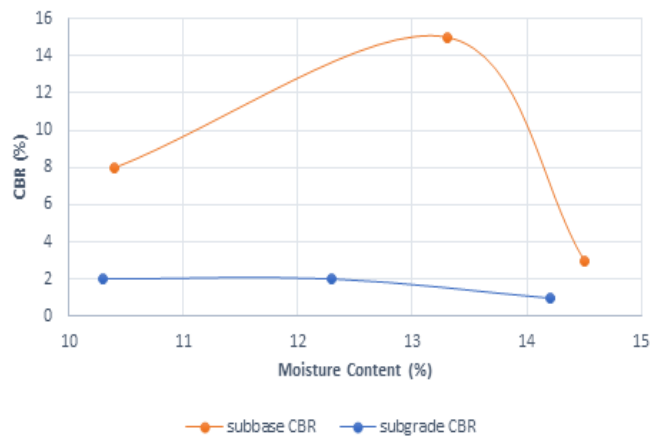
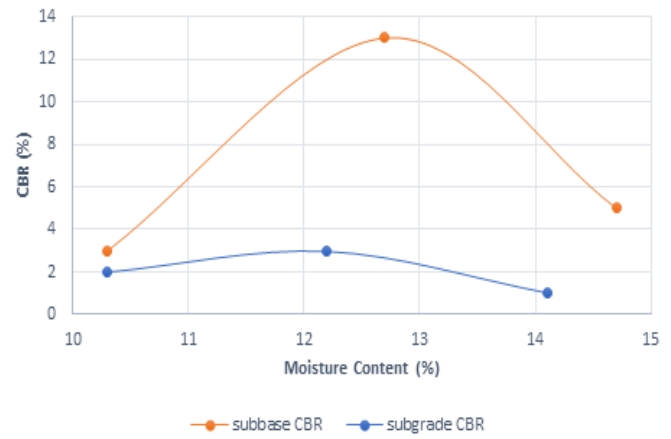
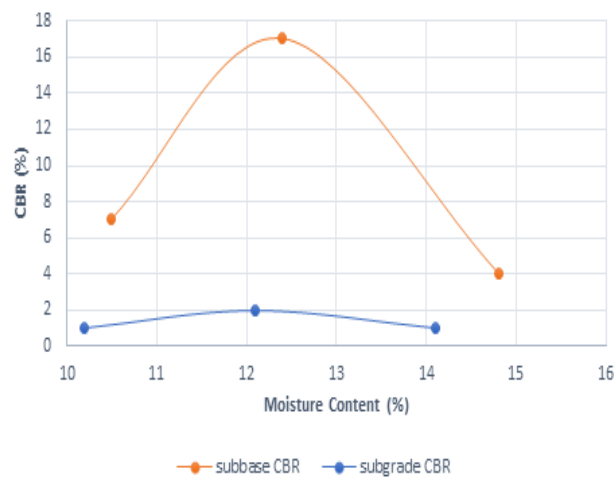
Fig. 4(a): CBR versus Moisture Content for Sample SS_{B1}

Fig. 4(b): CBR versus Moisture Content for Sample SS_{B2}

Fig. 4(c): CBR versus Moisture Content for Sample SS_{B3}

Fig. 4(a – c) show that the CBR values at OMC for Enugu's sub-base soils range from 13% to 17%, while that for sugrade range from 2% to 3%. These values are below the minimum values of 20% and 6% for sub-base and sugrade soils respectively. Thus, the reident soils do not possess the required CBR values for sub-base and subgrade and are not good for pavement construction.

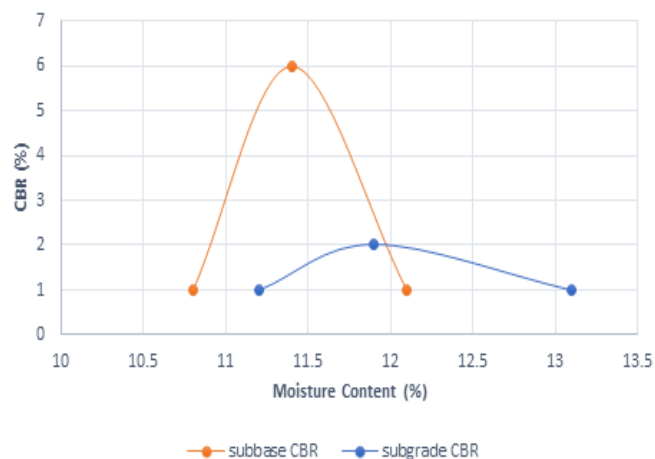
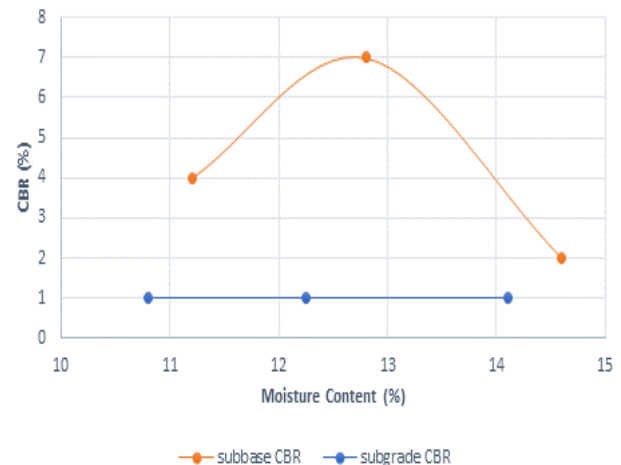
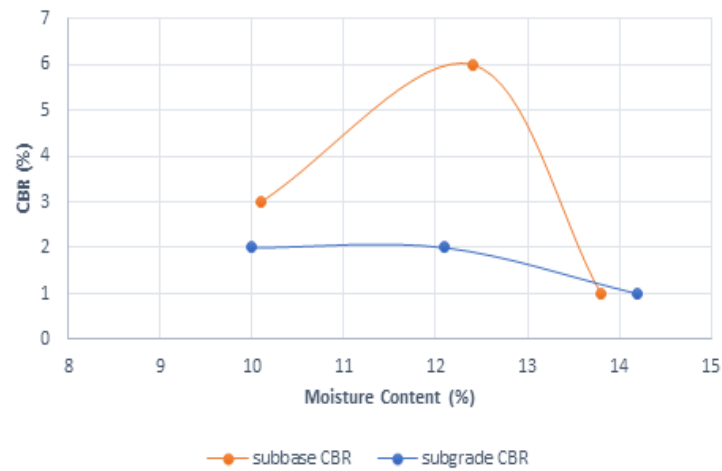
Fig. 5(a): CBR versus Moisture Content for Sample SS_{C1}

Fig. 5(b): CBR versus Moisture Content for Sample SS_{C2}

Fig. 5(c): CBR versus Moisture Content for Sample SS_c

The CBR values at OMC for sample SS_c (Imo state) are shown in Figures 5(a – c). For the sub-base, the values ranged from 6% to 7%, similar to Sample SS_A, while it ranged from 1% to 2% for the subgrade. These values are also below the minimum CBR values for sub-base and subgrade soils. As a result, the soils are not suitable for pavement construction. This is in line with the findings of [22]; [15]; [1]; [11]; [2]; in their various studies.

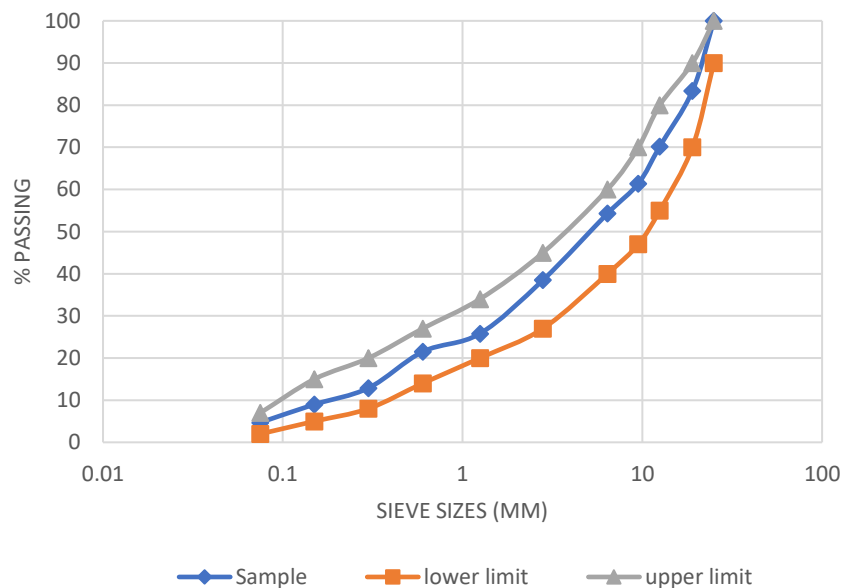
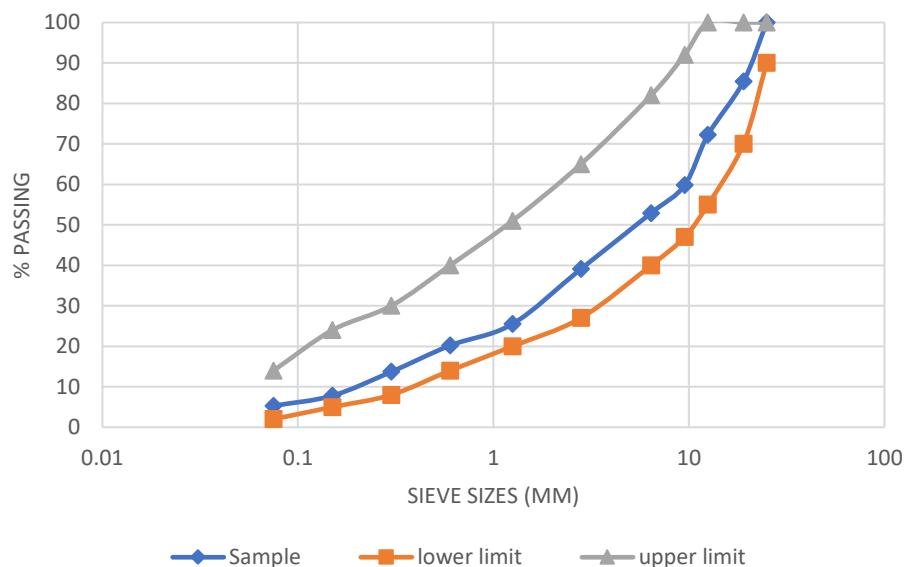
Fig.6 (a): Grading Envelope for Binder Course of Sample AC_A

Fig. 6(b): Grading Envelope for Wearing Course of Sample ACA

The grading envelopes for the wearing and binder courses of the asphalt concrete for sample ACA have been plotted in Figures 6(a) and 6(b). For the efficient performance of flexible pavements, the asphalt concrete mixes in the binder and wearing courses of the pavements must fall within the specified upper and lower limits of percentage passing by weight which forms the grading envelope. It can be observed that the asphalt sample from Anambra state has their aggregate gradings falling within the grading envelopes.

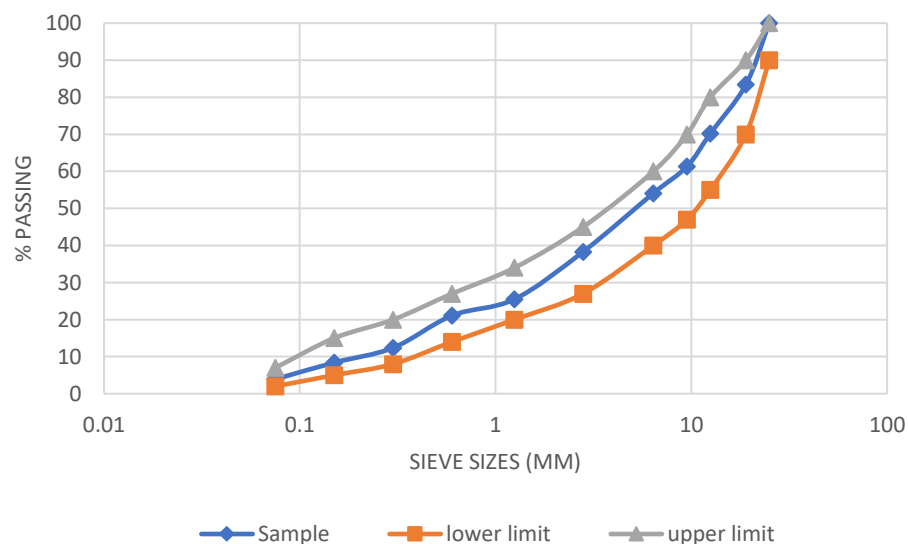
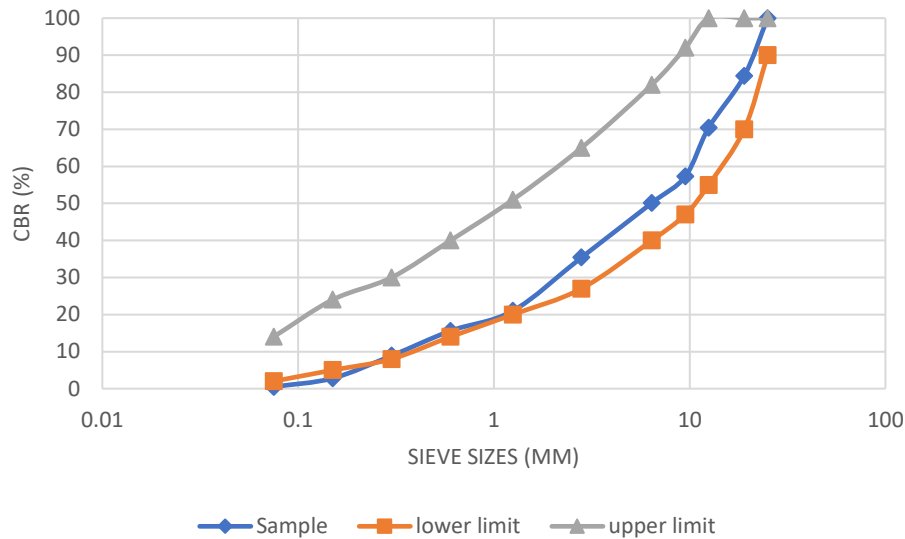
Fig.7 (a): Grading Envelope for Binder Course of Sample ACB

Fig. 7(b): Grading Envelope for Wearing Course of Sample AC_B

Figures 7(a) and 7(b) show the plots of the grading envelopes for the binder and wearing courses of sample AC_B. It can be observed that the asphalt concrete mixes for the both courses fell within the specified upper and lower limits of the percentage passing weight. Thus, the asphalt concrete at this location can be said to be of sufficient and suitable particle compositions.

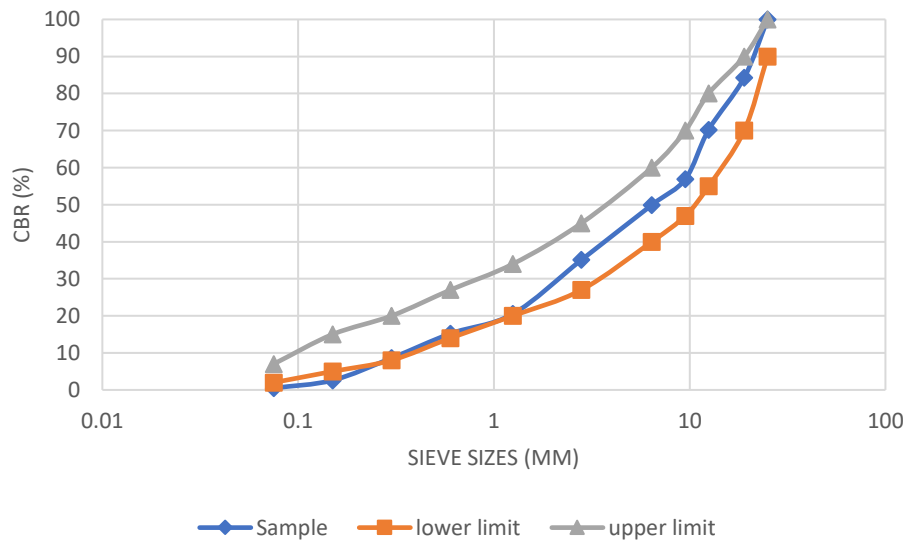
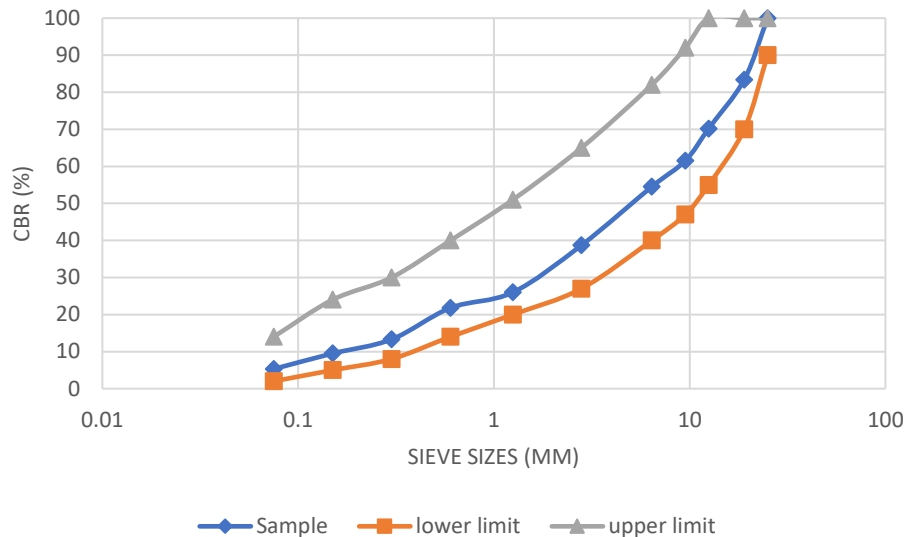
Fig.8 (a): Grading Envelope for Binder Course of Sample AC_c

Fig.8 (b): Grading Envelope for Wearing Course of Sample ACc

The plots in Figures 8(a) and 8(b) demonstrates the particles grading of sample ACc when compared to the specified upper and lower limits of percentage passing by weight. It can be observed that sample's grading curve for the binder and wearing courses fell within the specified grading limits. This implies that the asphalt concrete at the location has proper aggregate composition.
