# A modified approach for removal of damaged implant abutments: A clinical report

**Keywords:** Implant, Abutment, Abutment removal, Implant Complications

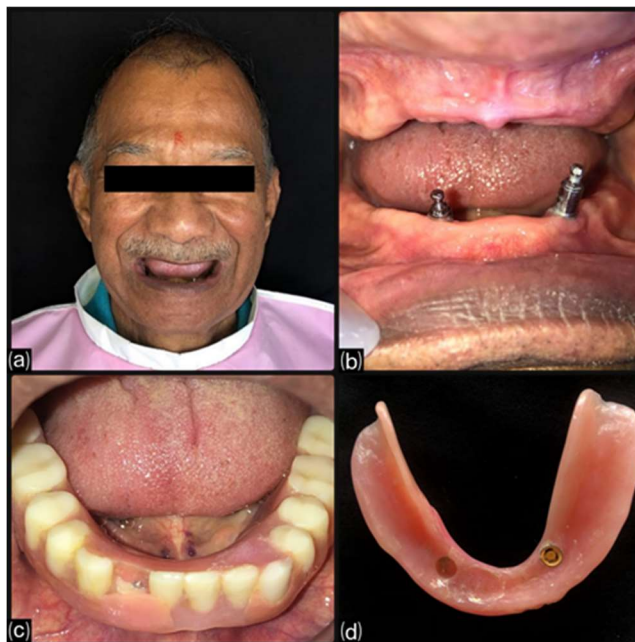
The overdenture ball abutments had severely worn out and had irregularities on its surface. The patient desired a new prosthesis on the same implants; thus, it was decided to replace the previous abutments with new ones (Figure 1). As the abutments structure was damaged, the removal of the same was quite challenging. Multiple techniques were tried to remove it without damaging the implants. This article presents a modified approach for the removal of a damaged mandibular overdenture abutment without compromising the implant.

**Figure 1** (a) Extra Oral Image, (b) Intra Oral Image, (c) Prefabricated Dentures (Occlusal View), (d) Prefabricated Dentures (Intaglio View)

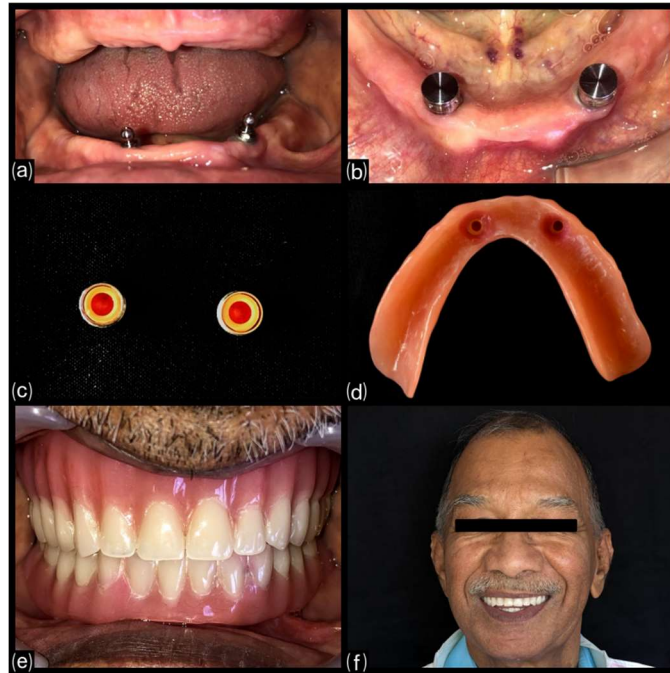
**Figure 3** (a) Intra Oral Image with new ball abutments, (b) Intra Oral Image with metal housing, (c) Metal Housing with O-Rings, (d) Fabricated Mandibular Denture (Intaglio View) (e) Fabricated Dentures (f) Post Treatment Extra Oral Image

New ball abutments (Adin) were placed on the implants which were followed by the fabrication of new implant-supported overdenture prosthesis (Figure 3).
