Analysis of Concrete Cracks and damage on Base Slab of Caissons at the Manufacturing Stage taking into account the Settlements of the Backfill and the IP-CCVs

The objective of this article is to analyze the causes and the state of the damaged parts of the caissons during their embarkation on the floating dock, as part of the realization of the new container terminal project at the Djen Djen Port, in Jijel province in Algeria, and to take the necessary measures for the repair and prevention of any recurrence. On the workshop site, following the displacement from the sliding formwork station to the curing station, the appearance of cracks in the base slab of the fifth caisson was observed, with the same characteristics as the cracks that occurred on the base of the previous caissons. We have studied this phenomenon and make analysis with the observations, the explanation and the measures to be taken in order to prevent the repetition of this problem, because the topographic verification of the leveling of the workshop platform stations and the backfill settlement verification of the same platform are carried out with good results; in contrast with the differential settlement of the

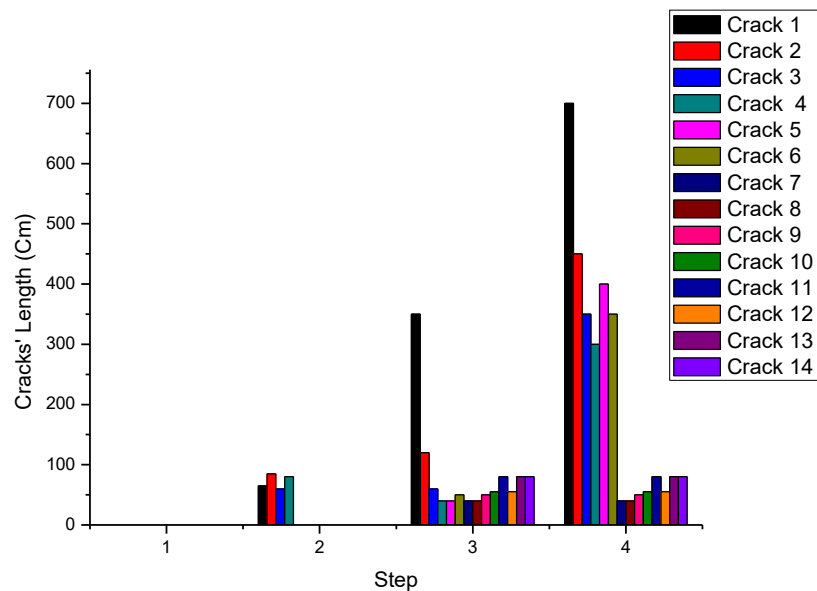
The Cracks 1, 2, 3 and 4 (figure 10) are the first that they appear in Step 2 with lengths of 60 cm, 85 cm, 50 cm and 80 cm and widths of 0.1 mm, 0.2 mm, 0.35 mm and 0.2 mm respectively. In Step 3 there is an evolution of the crack (1) up to 350 cm in length and 1 mm in width, and of the crack (2) up to 120 cm in length and 0.3 mm in width, With the appearance of new ten (10) cracks (5, 6, 7, 8, 9, 10, 11, 12, 13 and 14) with a maximum length of 80 cm and a maximum width of 0.4 mm. A large increase of the widths of cracks 1 (700 cm), 2 (440 cm), 3 (350 cm), 4 (300 cm), 5 (400 cm) and 6 (350 cm) in Step 4 is remarkable, unlike cracks 7, 8, 9, 10, 11, 12, 13 and 14 that they remain with the same widths, therefore; its widths remain stable except cracks 4 and 5 increase to 0.3 and 0.5 respectively.

Figure 10: (a) Length of the Cracks.

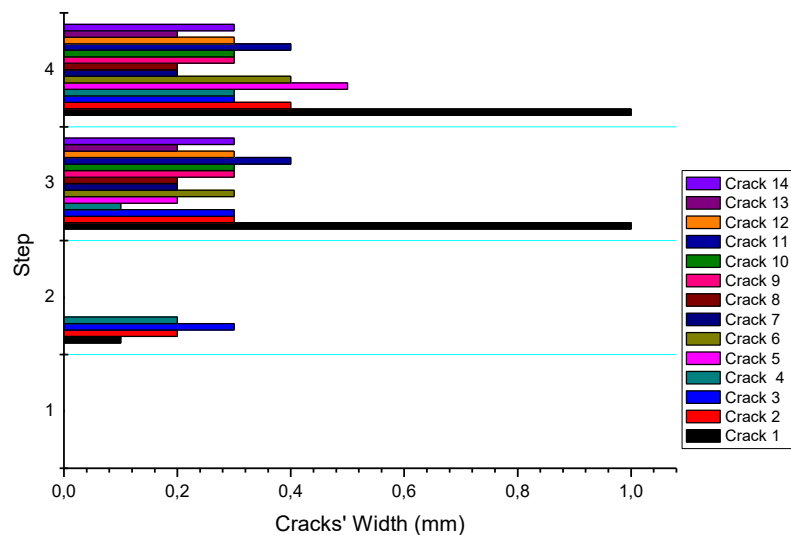
Figure 10: (b) Width of the Cracks.

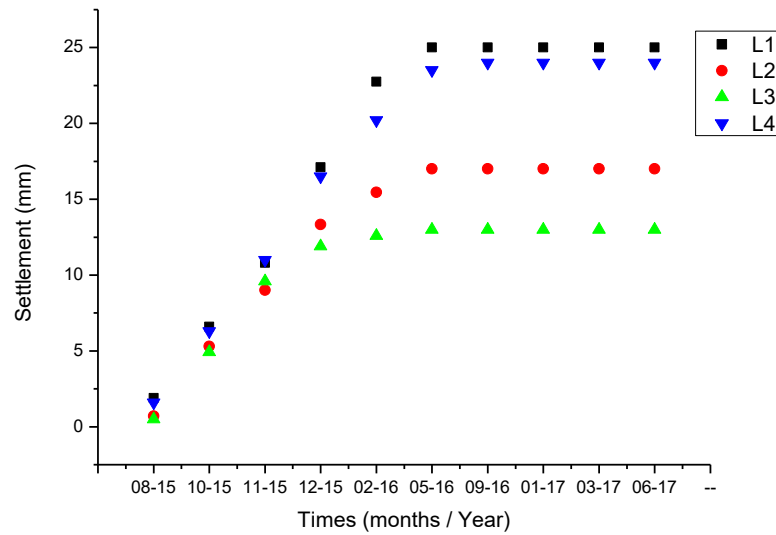
This cracks conduct us to check their causes, so, we start with checking settlements of the workshop embankment. Figure (11) shows that there are four (04) lines at a length of 112 m and a width of 38 m of the platform already monitored between August 2015 and June 2017, which show a maximum settlement of 25 mm in a period of two (02) years, as well as the curves settlement have stabilized since May 2015, and that the maximum difference between the first line (L1) and the fourth line (L4) is 12 mm, so these amounts of settlements cannot be a problem, so they are considered as negligible quantities, especially considering the enormous dimensions of the caissons (figure 2).

Consequently; the results are perfectly satisfactory, no soil settlement was observed and no geotechnical problem was encountered [14], which compelled us to start monitoring a concrete platform of 1.75 m thick on the compacted backfill (figure 12 a), in order to verify its influence on the cracking of the caissons.

Figure 11: The results of the settlement of four (04) lines monitoring of caisson's workshop after platform implementation.

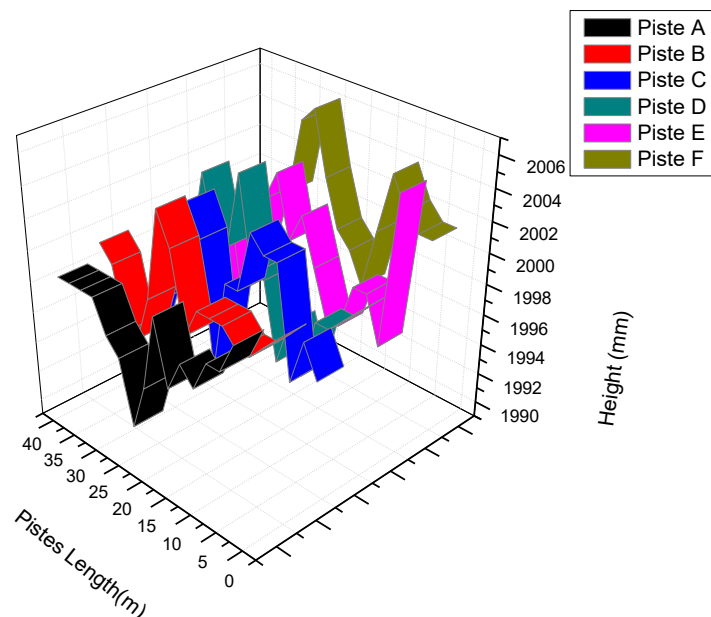
The reinforced concrete platform of the curing station (Step3), at a length of 38 m and a width of 30 m, was monitored in order to define the difference in the vertical warp along the third station (Step 3) between the six Pistes/ Tracks (A, B, C, D, E and F) forming the 1.75 m high platform, with 3 m for each track/ piste (figure 12a), in order to know the possibility of its impact on the cracks that occurred. Therefore, we arranged the measurements in a precise manner that includes all the pistes from its beginning to its end with a longitudinal spacing of about 2.5 m, in the sides and middle of each piste with distance of 1m between each transversal measured point. By taking into account that the landmark of designed vertical concrete surface is ± 2 m (figure 12b), It can be observed in the left side of the piste A, that the maximum vertical warps are - 4mm, -5mm and -8mm along the piste's distance of 15m, 20m and 22.5m respectively. In the middle of the piste B; the maximum vertical warps are +4mm, -5mm and -5mm along the piste's distance of 25m, 30m and 32.5m respectively. In the middle of the piste C; the maximum vertical warps are -4mm, -5mm, -7mm, -4mm, -4mm and -7mm along the piste's distance of 2.5m, 7.5m, 22.5m, 32.5m, 35m and 37.5m respectively. In the middle of the piste D; the maximum vertical warps are -7mm, -4mm, -7mm, +4mm and -5mm along the piste's distance of 12.5m, 15m, 17.5m, 25m and 37.5m respectively. In the middle of the piste E; the maximum vertical warps are +5mm, -5mm, -5mm, -5mm, -6mm and -9mm along the piste's distance of 2.5m, 5m, 12.5m, 15m, 32.5m and 37.5m respectively. Finally in the right side of the piste F; the maximum vertical warps are +4mm, -4mm, +6mm and +5mm along the piste's distance of 10m, 15m, 25m and 27.5m respectively. Consequently; these amounts of warp cannot be a problem, so they are considered as negligible quantities, especially considering the enormous dimensions of the caissons (figure 2) and the huge surface of the concrete platform itself.

Figure 12 b: Monitoring results of the concrete warp of the 1.75 m thick platform.

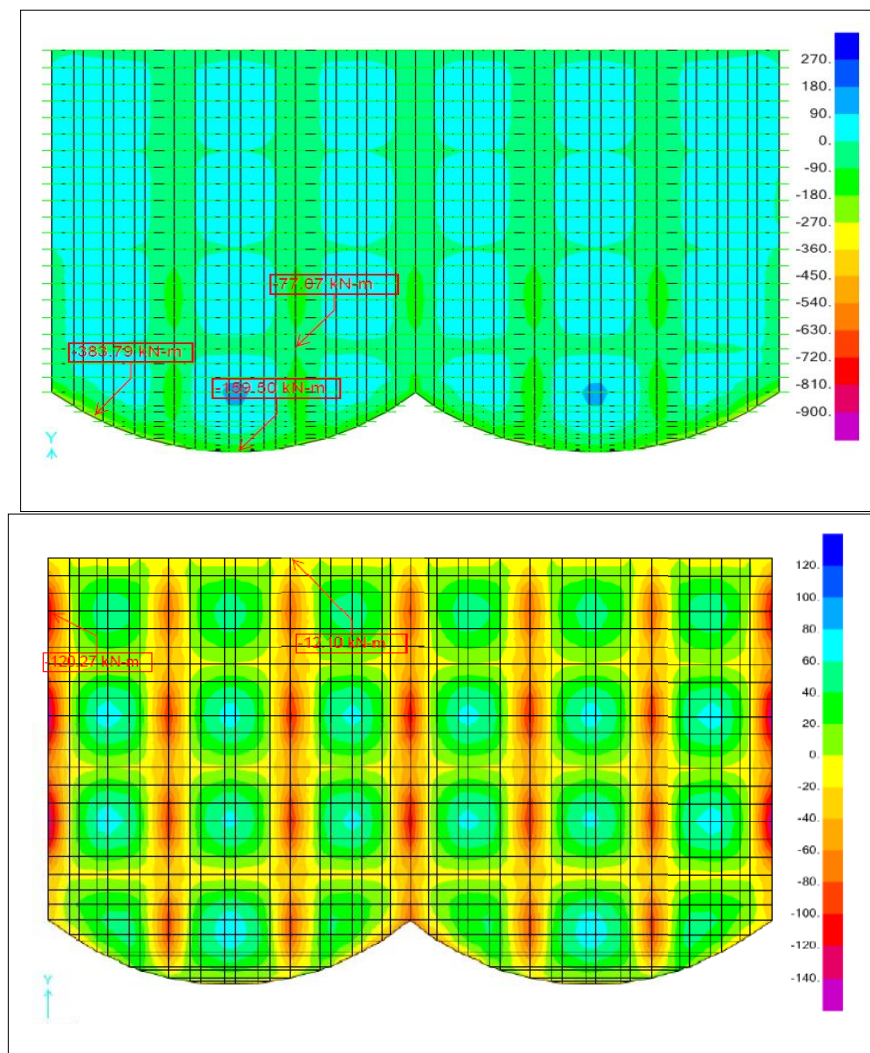
In figure (14) below, we can see the current state of the member force towards the direction of M11 of the base slab. Through the wall, this force decreases a lot in the base slab which joins the walls A, B, C, D. The real member force (in case of Service Limit State "SLS") generated in the base slab which joins the walls A, B, D is as follows:

- front wall (Wall-A), member force of the base slab towards direction M11: -159.50 kN • m.
- partition wall (Wall-B), member force of the base slab towards direction M11: -77.07 kN • m.
- rear wall (Wall-D), member force of the base slab towards direction M11: -12.10 kN • m.

Figure 14:: the member force generated in the base slab (direction of M11) (SAP-2000), (a) when operating the quay walls (Service Limit State), (b) when caissons' floating stage (Service Limit State).

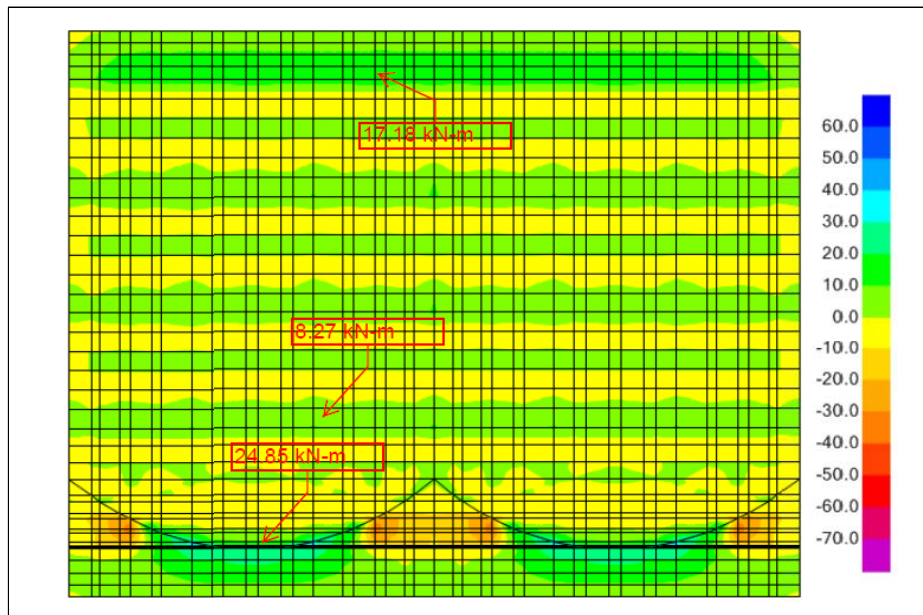
Figure 15 b: Base slab member force generated at the cure station towards the direction of M11 (SAP-2000).

According to the cracking examination for the reinforcing bars (reinforcements) which meet with the wall, taking into account the current spacing of the reinforcing bars, all of them comply with the standard of admissible cracking (table 4). In addition, it is always less than the maximum spacing to control cracking. As a result, it has been observed that there is no problem for the spacing of the reinforcements of the base slab.
