Comparison of transverse strength and impact strength of a high impact heat cure denture base resin with that of a conventional heat cure denture base resin reinforced with E-glass and polyethylene fibers: A research

Ubaid Iqbal, Talib Amin Naqash. Comparison of transverse strength and impact strength of a high impact heat cure denture base resin with that of a conventional heat cure denture base resin reinforced with E-glass and polyethylene fibers: A research. *Medical Science*, 2014, 15(59), 21-24

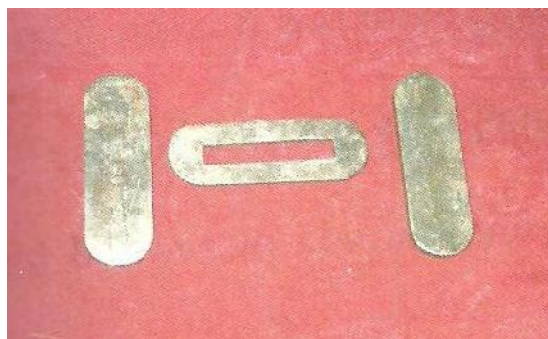
Figure 1 Master Die

A master die was fabricated with industrial iron (Figure 1). It was roughly rectangular in shape with two parallel sides. It had three parts namely base, body and lid. The body had a rectangular space of 65mm x 10mm x 3mm. The function of the body and lid was to confine and prevent the escape of molten wax until it solidified.

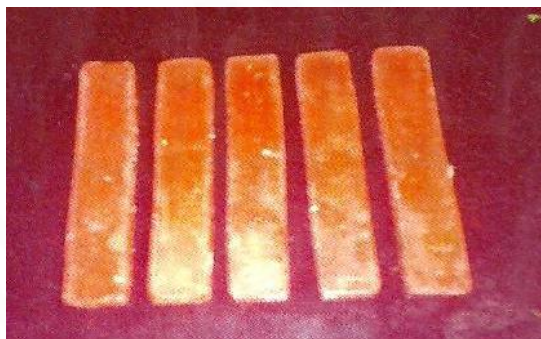
Figure 2 Wax Blocks

Modeling wax (No. 2, Hindustan Dental Products Limited) was melted and poured in the die space, until it was in level with the edges of die space. Once it had solidified and cooled to room temperature, the wax pattern was removed carefully from the die space (Figure 2).

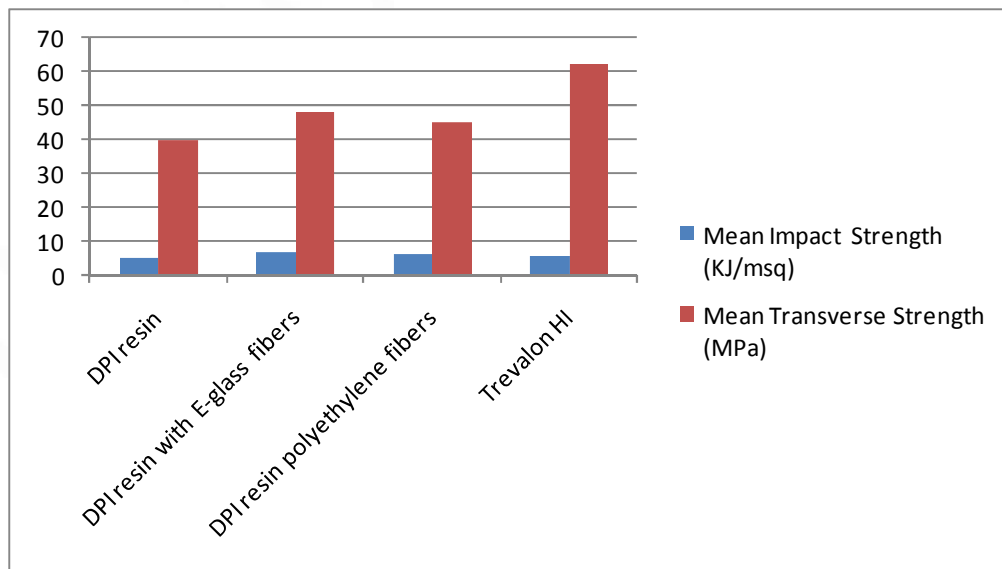
Graph 1

Mean impact and transverse strength of conventional DPI resin, DPI resin reinforced with E-glass fibers, DPI resin reinforced with polyethylene fibers and Trevalon HI

Eighty (80) samples were prepared; forty (40) were intended for evaluation of transverse strength and forty (40) were intended for evaluation of impact strength. The results obtained using Lloyd instrument and Charpy digital impact tester were tabulated, statistically analyzed and interpreted as shown in Table 1 and Graph 1.

Results revealed that there was significant increase in the transverse and impact strength values of conventional heat cure denture base resin (DPI) reinforced with E-glass fibers and polyethylene fibers.

Conventional heat cure denture base resin (DPI India) reinforced with E-glass fibers exhibited maximum values of transverse strength as compared to conventional heat cure denture base resin (DPI India) reinforced with polyethylene fibers. However the transverse strength values of high impact heat cure denture base resin (Trevalon HI) were still higher than conventional cure denture base resin (DPI India) reinforced with fibers.

The impact strength values of conventional heat cure denture base resin (DPI India) reinforced with E-glass fibers was greater as compared to conventional heat cure denture base resin (DPI India) reinforced with E-glass fibers.

When impact strength of conventional heat cure denture base resin (DPI India) reinforced with fibers was compared with high impact heat cure denture base resin (Trevalon HI), the conventional heat cure denture base resin showed increase in impact strength values.
